BEHAVIOR OF SAND-ASPHALT GROINS
AT
OCEAN CITY, MARYLAND

Miscellaneous Paper No. 2-59

May 1959

By
Robert A. Jachowski, Chief,
Design Branch, Engineering Division
Beach Erosion Board

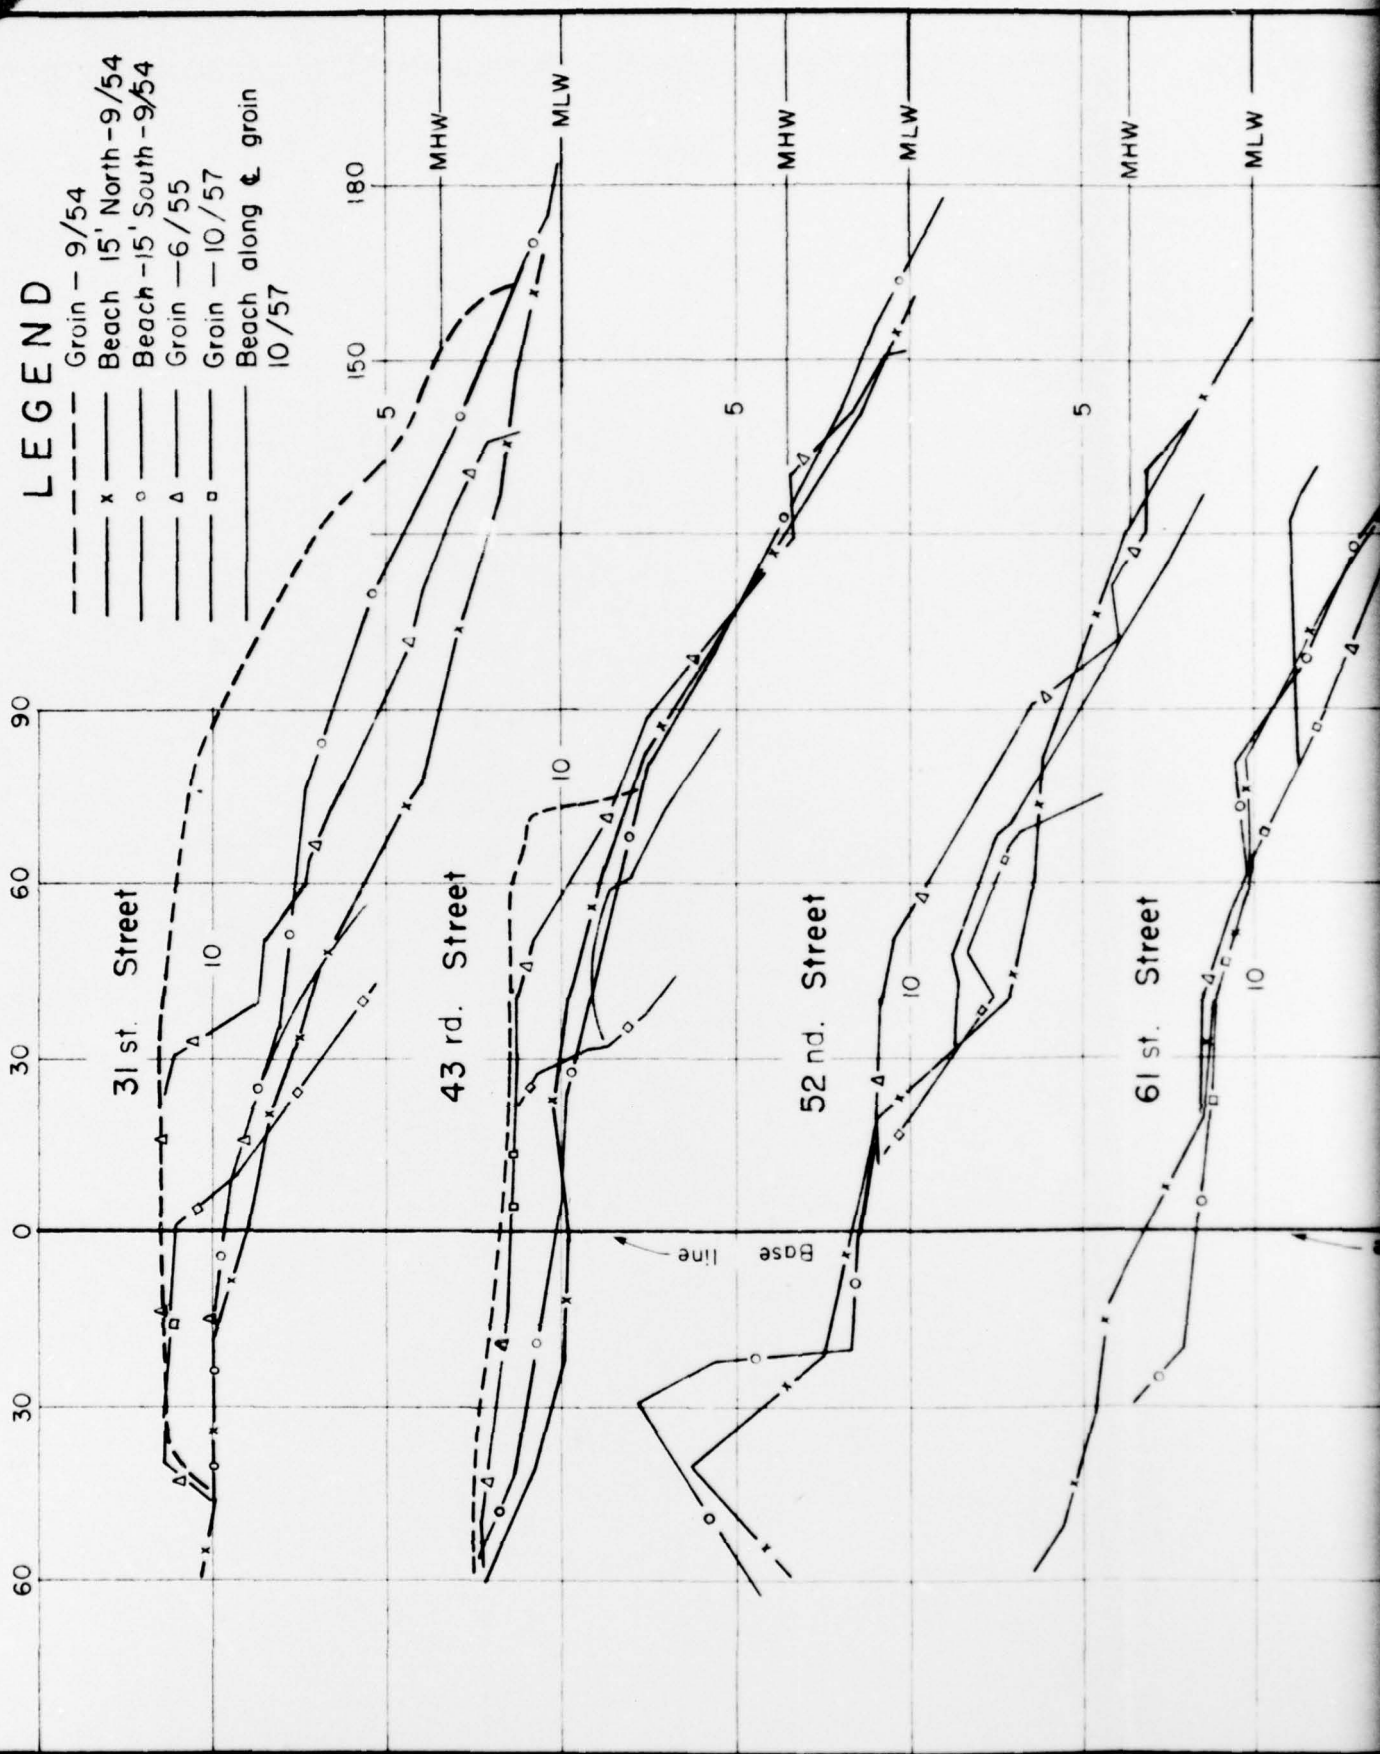
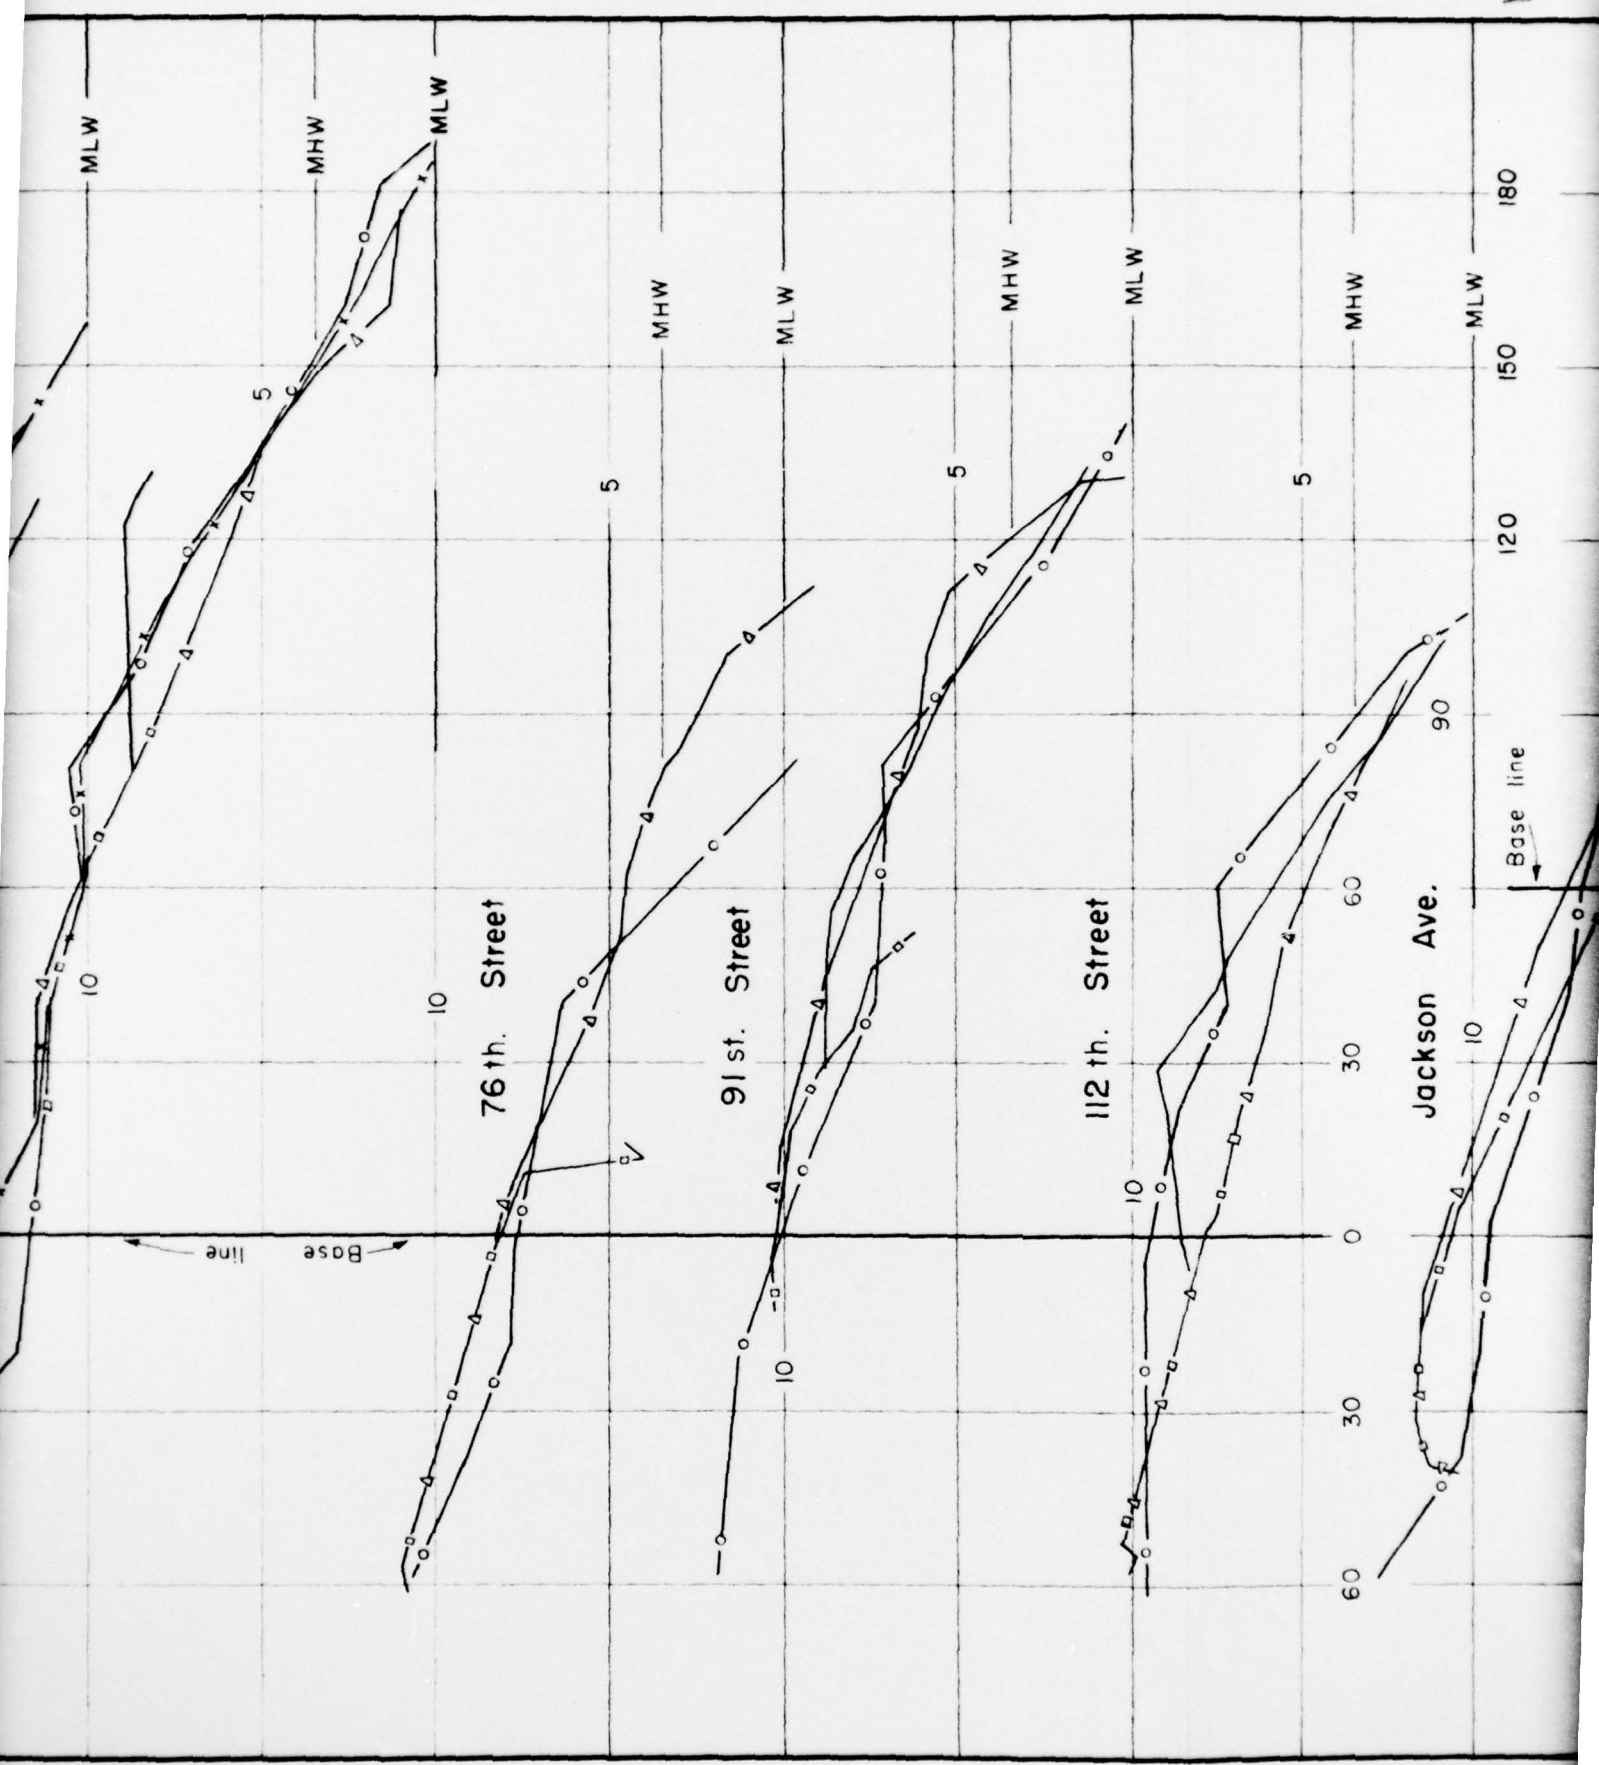
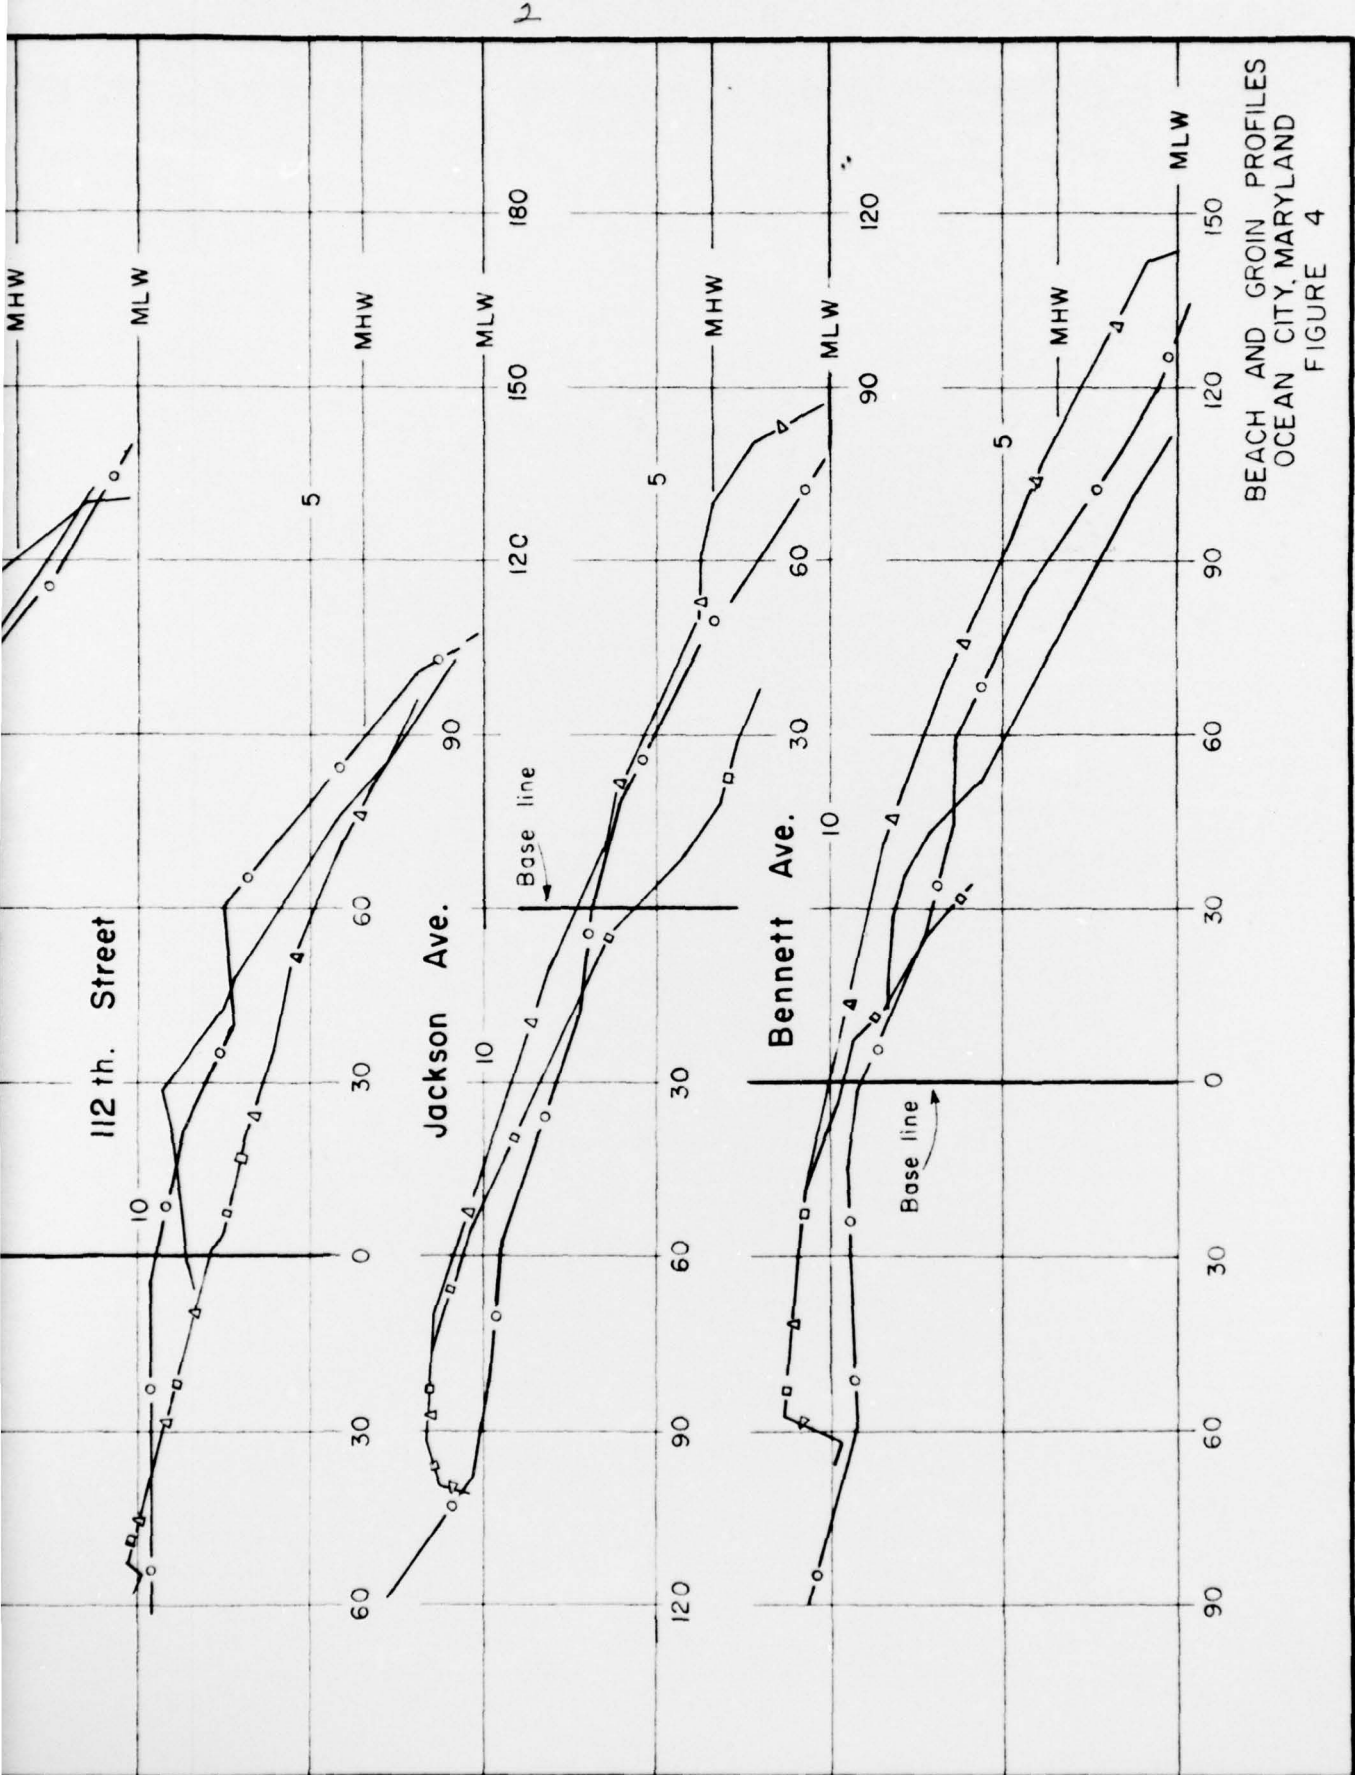
BEACH AND GROIN PROFILES
OCEAN CITY, MARYLAND
FIGURE 4

The September 1954 profiles of the 31st Street groin, shown on figure 4, indicated the severe exposure of the groin above the beach level. The 43rd Street groin had not been completed at the time of the survey and the remaining groins indicated on the figure had not been started. Photograph 1, figure 5, shows the breaching type of damage that occurred to the 31st Street groin as the result of the two hurricanes.

By July 1955, thirty-eight of the forty-three groins were completed. The June 1955 profiles on figure 4 provided the first comparative data for the early groins.

A comparison of the groin profiles on figure 4 for October 1957 and June 1955, indicates that in most cases the seaward end had been destroyed or had disappeared below the beach surface. The groins have

progressively settled with a few exceptions from the seaward toward the landward end. In some cases this settlement exceeded 4 feet, thus making the groins ineffective to retain the desired beach width. Data on the condition of the groins in October 1957, summarized in table 3, indicate that only 35 percent of the total length of the groins remained within 1 foot and 40 percent within 2 feet of the June 1955 profiles. A comparison of the beach profiles for September 1954 and October 1957 indicated that there had been a general recession of the high and low water shore lines during this period.

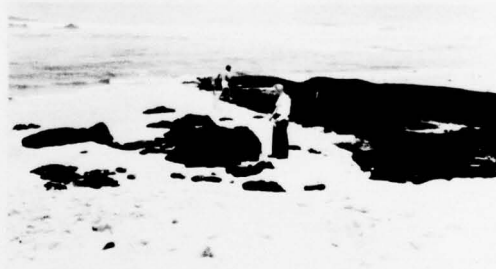
4
40th Street
July 1956

An analysis of photographs revealed that in September and October 1955 thirteen of the forty-three groins were barely exposed or not exposed at all in the tidal zone. The remaining groins showed signs of deterioration in three distinct forms: (1) Breaching, that is, the beach had eroded in the tidal zone, leaving a void or gap as seen in photograph 1, figure 5. This breaching varied between 10 and 40 feet in length. (2) End raveling, that is, the seaward end developed cracks as the result of undercutting and settlement, and wave action broke off and carried away the pieces. This type of deterioration is graphically shown in photographs 2 and 3, figure 5. (3) Side raveling, that is, the asphalt broke off one side of the crown or apron as the result of wave action undercutting the side or splitting along the longitudinal temperature cracks in the crown. The apron undercutting type of side raveling is seen in photograph 4, and the crown side raveling is shown in photograph 5, figure 5.

An analysis of the photographs of April 1956 indicated that many of the groins were still exposed, but by June of that year twenty-four groins were covered by sand in the tidal zone; seven were exposed only to a minor degree (less than 6 inches above the beach level, or only a small section in the surf zone, see photograph 6, figure 5); and twelve groins remained completely exposed. These twelve groins that were exposed in the tidal zone showed that deterioration of the end and north side of the groin had continued. Photograph 4 shows the condition of the 40th Street groin during this period. Severe erosion and undercutting is apparent.

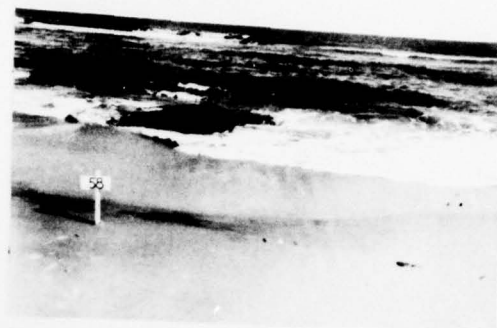
7
58th Street
Oct. 1957

The latest observations were made in October 1957 when profiles and photographs were taken. The photographs indicated that thirty-eight of the groins were not exposed in the tidal zone but four of these groins had minor exposed portions of asphalt only at extremely low tide (-1 foot MLW, see photographs 7 and 8, figure 5). Only five groins were exposed in the foreshore area and these ranged from barely visible to 3 or 4 feet of height exposed above the beach surface. Photograph 9, figure 5, shows the severe exposure of the groin at 76th Street (a comparison of photographs 6 and 9 shows the extent of the erosion to this groin in the 16-month period), whereas photograph 10, figure 5, shows the typical groin that was not exposed in the tidal zone.
